6th International Building Physics Conference, IBPC 2015

Deterioration of the wall of a historic stone building in a cold region and measures to protect it

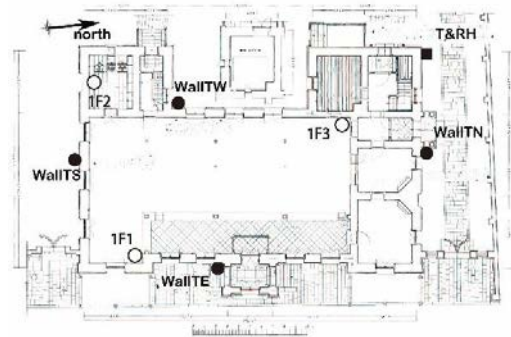
Fig. 6 Locations of temperature and humidity data loggers

In order to obtain data related to the number of freeze-thaw cycles that the outside stone wall undergoes, temperature data loggers were located on the outside walls facing north, east, south and west. The outside temperature and humidity were measured by a temperature and humidity data logger. Temperature and humidity data were also obtained inside the building. These data were obtained every hour. Fig. 6 shows the locations of the temperature and humidity data loggers. Points labeled WallTN, WallTE, WallTS and WallTW shows the locations of temperature sensors on the outside wall facing north, east, south and west, respectively. The point labeled T&RH shows the location of the temperature and humidity data loggers for measuring the outside environment. The points labeled 1F1, 1F2 and 1F3 show the location of the temperature and humidity data loggers inside the building.

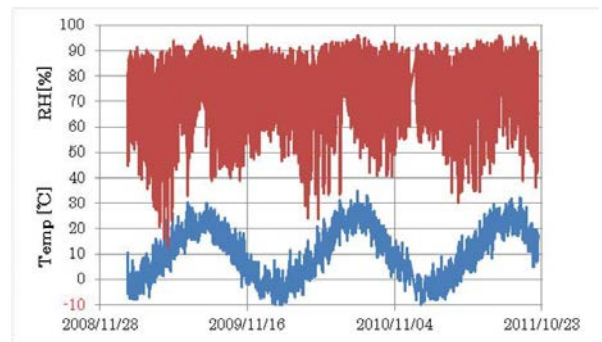
Fig. 7 Temperature and humidity changes outside of the building (2008-2011)

Fig. 7 shows the temperature and humidity changes outside of the building over 3 years from 2008 to 2011. The lowest temperature was recorded at around -10 degrees Celsius in winter.
