REPAIR OPTIMIZATION AND PERFORMANCE ANALYSIS OF THE ASPHALT PROTECTION LAYER OF THE SOUTHERN BREAKWATER IN FRONT OF THE PORT OF AMSTERDAM

Stefan van den Berg¹, Rolf Bruins², Arnaud Casteleijn³, Niek Leguit⁴, Peter Brand⁵

Keywords: breakwaters, asphalt, mastic, protection layer, damage, repair, design, failure modes, hydraulic loads

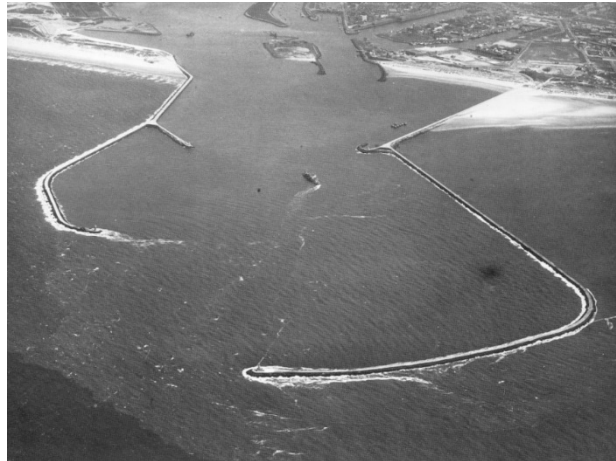
During the years 1960 – 1967 the extension of the breakwaters was constructed. Figure 3 shows a photo of the constructed breakwaters. During the construction, failure of the top layer occurred and resulted in sliding of large pieces of stone asphalt downward the slope. The mixture of stone asphalt was changed several times over the construction period to increase stability. The slope was changed from 1:1.5 to 1:2 (southern breakwater) and even 1:2.5 (northern breakwater). After these changes construction failure still occurred. The roundhead of the southern breakwater was a difficult part to construct due to its forward position and heavy wave loading.

Figure 3. Photo of the breakwaters, on the right the longer southern breakwater, left, the northern breakwater.

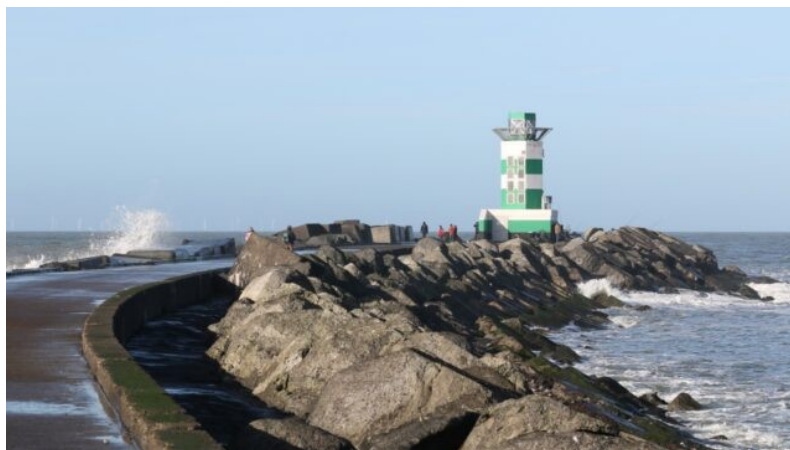
Figure 4. Photo of the breakwater with concrete blocks.

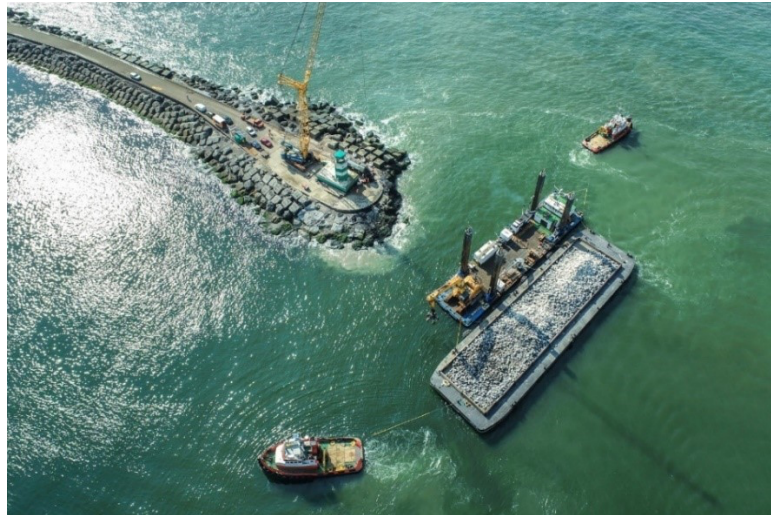
In 2020 the repair took place from water and land, see Figure 8. During construction in 2020 setbacks were encountered due to bad weather and wave conditions around the head of the breakwater causing severe delay. For example, in 2020 in total 32 workable days were registered, while 39 days the equipment was idle due to wind and wave conditions. Based on the weather and wave conditions in 2020, it was decided to repair in 2021 from land only.

Figure 8. Land-based and sea-going equipment used by Paans Van Oord.
