## **RAISING THE ALARM: HOW THINGS GO WRONG**

Chris Brown BSc, MICE (formerly MIEAust - retired)<sup>1</sup>

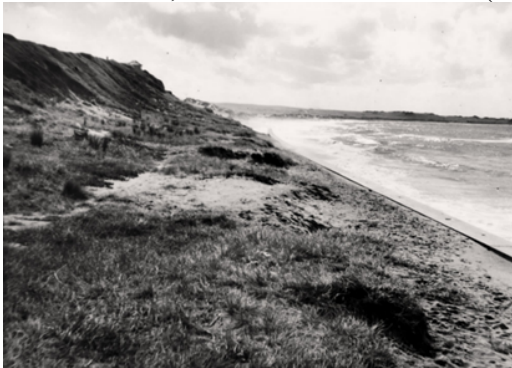
In the late 1930s a vertical reinforced concrete seawall was built to protect the Prince Street dune in North Cronulla, NSW from storm erosion (Figure 4), which erosion was exacerbated in later years

Figure 4. North Cronulla seawall in 1949

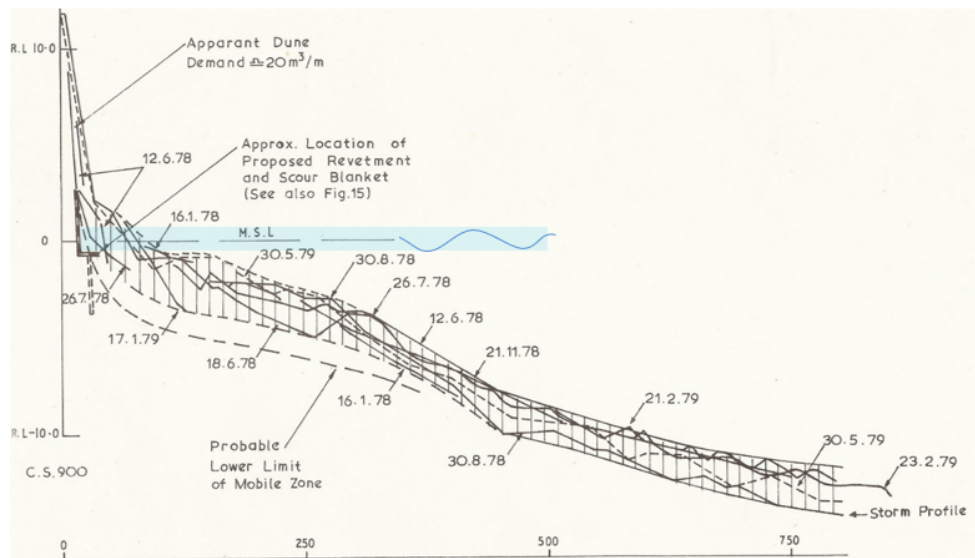
The use of a flexible scour apron was considered to be significantly cheaper than a sheet pile toe, and avoided the problems with the hidden remains of the old wall. The concept was to locate the scour apron below the level of 5% AER risk of scour of exposure (Figure 7) to the seawall design wave climate of 3.6m 12 second waves

Figure 7. Location of seawall in beach erosion hysteresis

Under cost pressures from the client, the crest level was lowered, and more importantly, the scour apron became a sloping revetment, with transition raised to High Water mark, so becoming a revetment

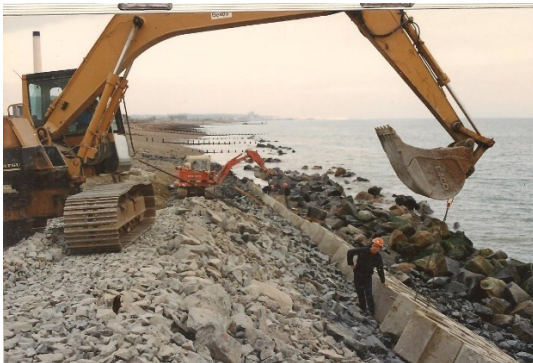
A Seabee revetment was designed by a reputable experienced consultant, intending to utilise coarse crushed concrete as the underlayer over native shingle as bulk fill. Problems of contamination delayed production of crushed concrete and alternative rock underlayer was specified, but deliveries were inadequate to meet the program (Figure 14).

Figure 14. 1989 Working downdrift 5-10min cycle time.

The vulnerability of the structure during the construction phase to overtopping by storms, and the washing out of the shingle bulk fill (placed at slope of 1:1.5, far steeper than the natural angle of a shingle beach) was not appreciated by the construction team, with inevitable consequences.

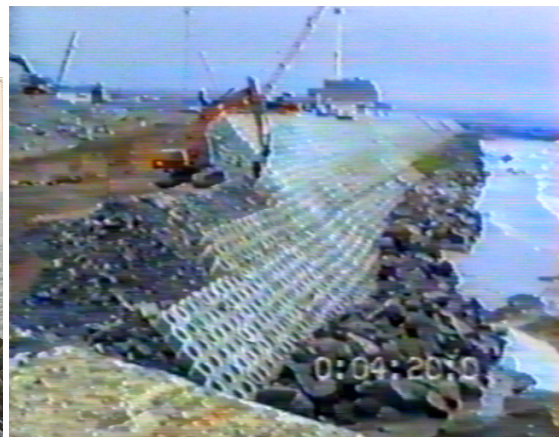
Figure 15. 1990 Working updrift, 22second cycle time

Following a construction sequence review over the following winter, a revised construction programme was developed, which saw the whole revetment completed in less time that had been spent in the previous year's attempt (Figure 15). Critical points of the review were the protection of the shingle fill during the construction phase. This was achieved by ensuring continuity of supply of underlayer materials, working quickly away from one end towards the weather, and establish gabion bastions at intervals to provide fall back retention of the shingle. Due to the new efficient method of working, the 500m main revetment was completed in 13 weeks without any weather incident.

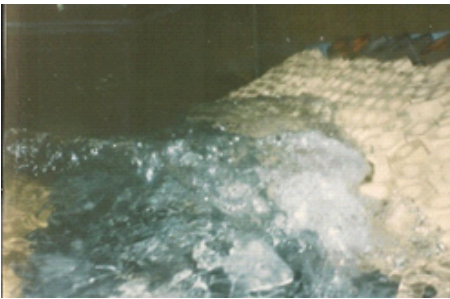
Figure 17. Mach stem wave in the flume..

An open trench was left at the top of the slope, below the crest level of the existing vertical wall. Testing was carried out to 130% of nominated design conditions to investigate potential problems of Mach-stem reflections on the trailing leg (Figure 17).

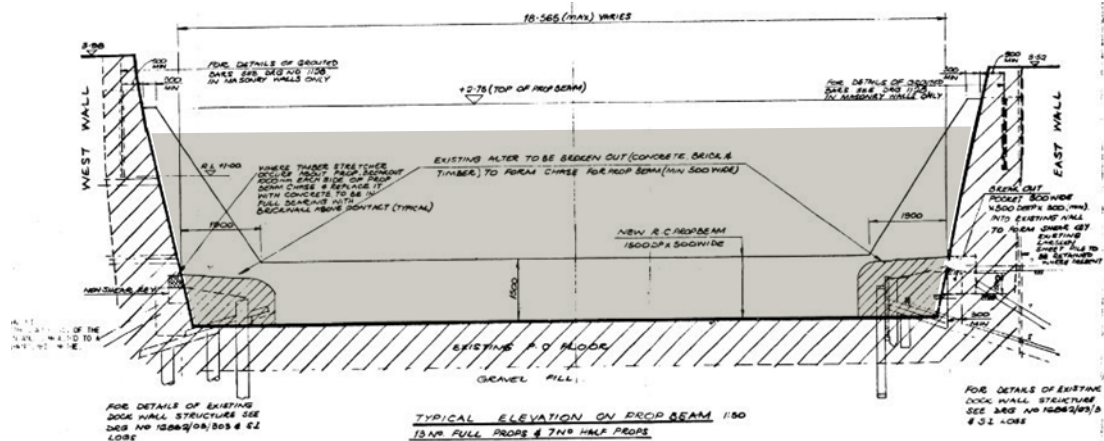
With no surviving drawings, there was little information about the dock, except the alignment of the dock walls, and that it was tidal and partially filled with mud and silt from the Thames. This was deemed a contaminated waste and had to be removed (Figure 19).

Figure 19. Blackwall Yard 1803 graving dock cross-section, full of silt to the level shown by shading at commencement.

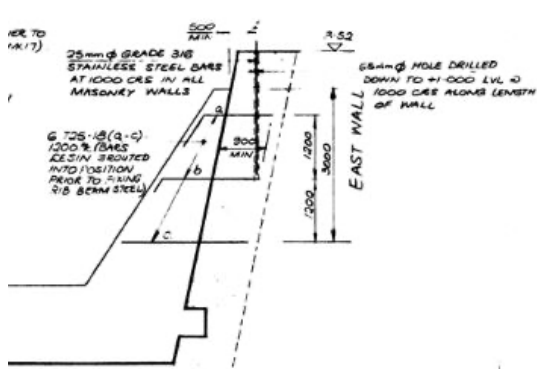
Figure 20. Detail of anchors

All work let on the project was let as fixed price lump sums, and no contractor would be found who would undertake such work entirely at their risk. The eventual solution was to form reinforced concrete ribs to resist the soil pressure when the dock was empty, and with a shear key and epoxy anchors to support the wall against further decay and against the possibility of subsequent excavation of the retained soil when the dock was full (Figure 20). The anchors were 25mm stainless steel bars to be installed in 900mm predrilled holes, with 3 pairs per rib. The loads were very conservative and it was deemed that testing would be unnecessary. A great mistake.

It was a mistake by the TA designer and the consultants own internal peer review procedures to omit random testing of the rib anchors. Contractually, it also left the consultants in a reputationally vulnerable position to have agreed to the role of advisors and not certifying inspectors, relying on the contractor to act on advice to break out bad work. Good intentions cannot be relied upon. Nevertheless, oversight by personnel understanding what the design intent of each element meant that these errors were identified and corrected. Recent review suggests that these details have not been recorded on the available as built drawings (Figure 21).

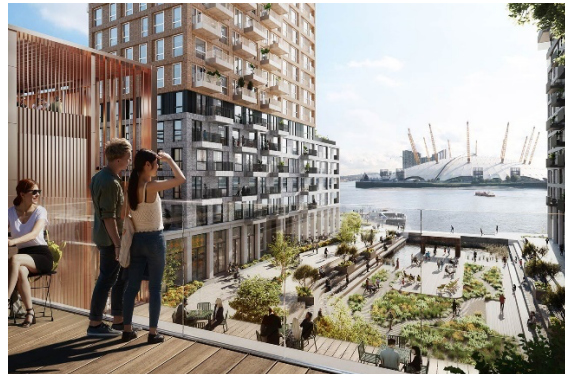
Figure 21. Future plans for development

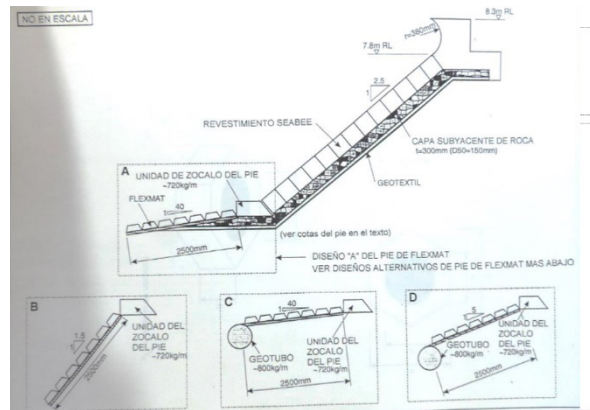
Laboratory tests were carried out at UNSW Water Research Laboratory at Manly Vale Sydney in 1998 using a moveable bed model and there were problems of instability of the narrow scour mat, such that a geotube was recommended at the seaward end (Figure 22).

Figure 22. Examples of Scour Apron profiles tested

A video recording of the construction shows a different profile being built, with no geotube at the toe and probably to Profile A in Figure 22 (without the underlayer) rather than the profile recommended by the Laboratory (Figure 23). No documentation has been discovered to explain this discrepancy, neither contract nor as-built drawings, or any other reports. The shape of either toe beam was such that seaward rotation and sliding is possible if the scour mat fails to retain the underlying sand.
