A CASE STUDY ON THE MAJOR DAMAGE AT A PORT: DAMAGE ASSESSMENT AND UPGRADE OF THE BREAKWATER

INTRODUCTION

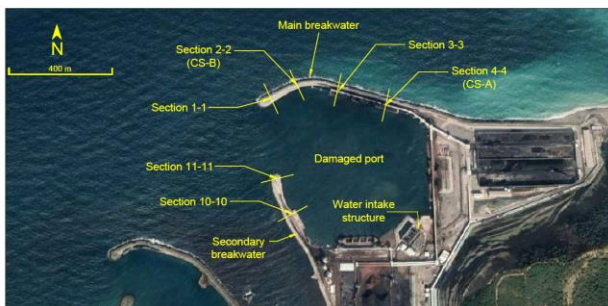
Figure 1 - Layout of the port (Google Earth, 2023).

The breakwaters were severely damaged during a storm at the Black Sea. The port was visited to observe and record the damage, collect available data, and interview the eyewitnesses. This field survey showed that Sections 2-2 and 10-10 of the breakwaters (Fig. 1) close to the entrance, failed during the storm. The crown-walls at Section 2-2 overturned towards the harbour direction (see Fig. 2) before the crown-walls at Section 10-10 overturned towards the seaward direction. The seaside and the rear side armour layers of the non-failed sections
