RECONSTRUCTION OF THE MONASTERY NEXT TO THE PRAGUE CASTLE

ABSTRACT. The paper deals with a rehabilitation of the historic building of Carmel Monastery next to the Prague Castle. A structural survey of building was carried out and the historical drainage and ventilation system was identified. Based on structural survey in-situ the reasons of failures were analyzed and remedial works of historic monastery were proposed.

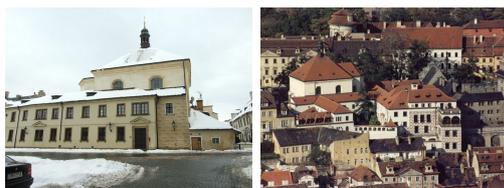
FIGURE 1. Carmel Monastery in the Prague Castle Square, view to the southern terrace of monastery.

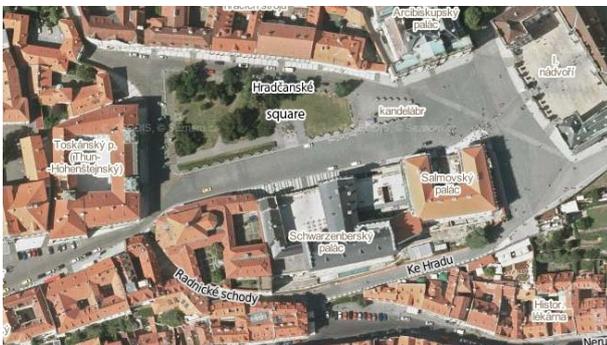
FIGURE 4. Location of the monastery on a steep south side of the castle promontory between Prague Castle Square and Radniční schody (Town Hall Stairs).
