The Impact of Climatic Factors to the Structure of Unprotected Expanded Polystyrene (EPS) External Insulation on Building

Edgaras Mickevičius¹, Asta Kičaitė^{1*} and Andrius Buska²

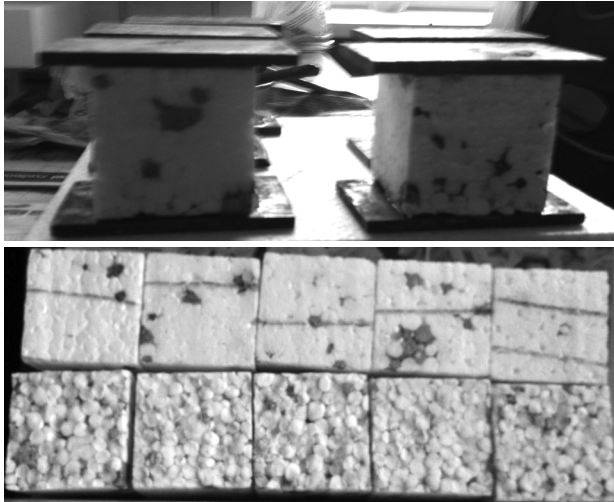
Fig. 8. Expanded polystyrene samples for tensile strength testing

The results of the testing were unequal depending on the nature of breakage. Samples with even surfaces broke at the centre, average tensile strength was 84.3 kPa, while the nature of the breakage of damaged samples varied. It can be seen in Fig. 9 that the values for damaged expanded polystyrene samples were in the range of 65.2–99.1 kPa. The instances of sample breakage can be seen in Fig.11. In comparison with undamaged samples, the sample breakage through the sample lowest value (78.3 kPa) is higher than breakage through damage zone (65.2 kPa) (Fig. 9; Fig. 10). According to the control sample determination of the compressive and tensile strengths, we can maintain that expanded polystyrene should be EPS 70. The producers in Lithuania do not provide tensile strength in declarations of conformity. According to EN 13163 only one strength parameter should be declared. It is strange why producers only declare compression strength as the required tensile strength should be not lower than TR100 for all ETICS systems; therefore, the producers don not have any confirmation that their own system confirms to all required properties according to ETAG 004. According to the possible producers the samples do not meet the normative strength requirements for application. Tensile strength is lower than 100 kPa. Usually, for plastered facades not lower than EPS 70 is used.
