The Pitfalls of Risk Based Inspection: an Insurer's View of the Chevron Richmond and Tesoro Anacortes Incidents

Ian Clarke

Zurich Insurance Company, London, UK
ian.clarke@uk.zurich.com

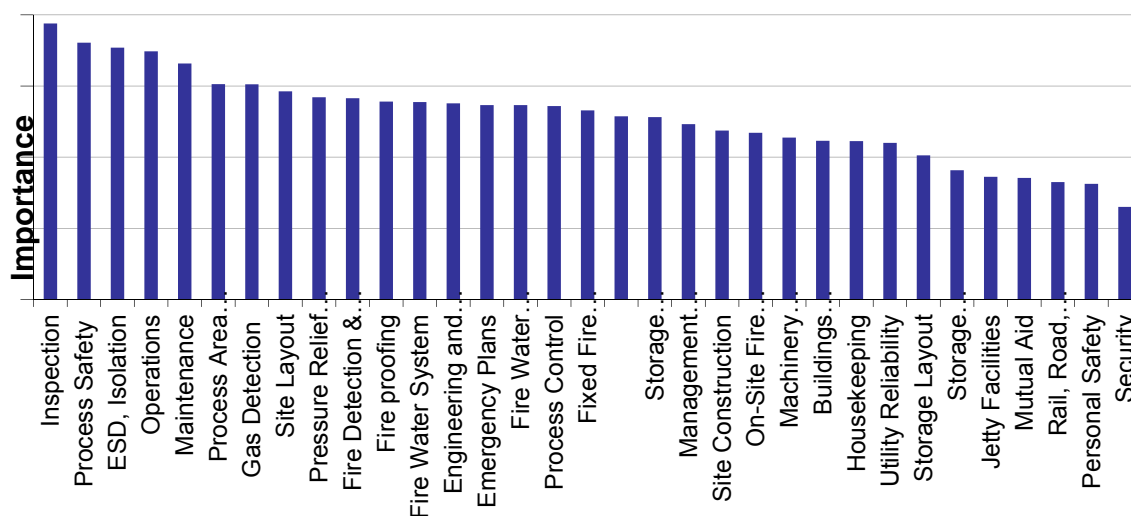
Below is a chart extracted from the Marsh Loss Control Newsletter. Marsh regularly canvass insurance company risk engineers to determine what issues are most important, in order to ensure their reports provide the information these engineers need to adequately assess the risk for their underwriters. It is prudent to note that inspection comes top of the list.

Figure 1: Items of importance to insurance companies. From Marsh Loss Control Newsletter 2011 Edition 2
