Damage Detection in Free–Free Glass Fiber Fabric Composite Beams by measuring Flexural and Longitudinal Vibrations

Keywords-Glass Fiber Composite (GFC); impulse excitation; free–free beam; flexural vibration; longitudinal vibration; natural frequencies; damage detection

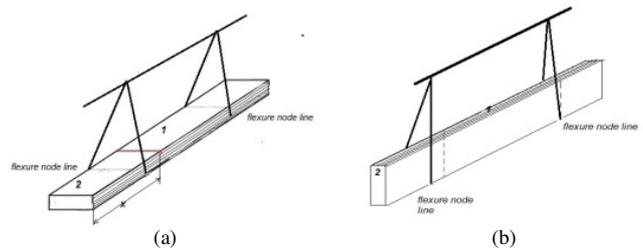
To realize "out-of-plane" bending, in which the direction of displacement is perpendicular to the large plane of the specimen, the diagram of suspension is shown in Figure 3(a). The scheme given in Figure 3(b) is used to excite the in-plane oscillations. The microphone is placed close to the specimen above the anti-node point.

Fig. 3. Schematic representation of the beam attachment for the excitation of free flexural vibration. (a) out of plane flexure mode, (b) in-plane flexure mode, 1 - impulse point, 2 - microphone point.

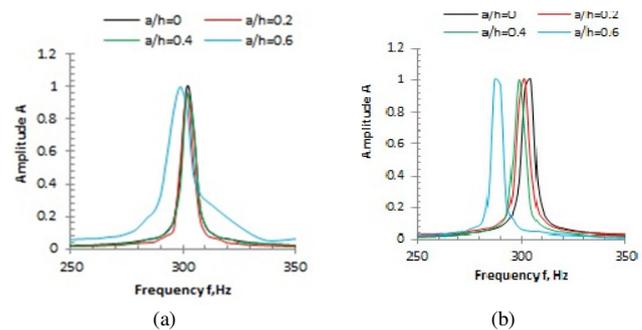
Figures 5 and 6 show the first resonance frequencies obtained during the out-of-plane bending vibrations for intact specimens and for beams with defects located at distances x equal to $0.1L$, $0.2L$, $0.3L$, and $0.5L$ at different crack depths. It can be noticed that the presence of a defect leads to a decrease in the natural frequencies.

Fig. 5. First natural frequency of flexure vibration test for intact and damaged beams. (a) Notches located at $0.1L$ with different depths $0.2h$, $0.4h$, $0.6h$. (b) Notches located at $0.2L$ with different depths $0.2h$, $0.4h$, $0.6h$.

As the distance to the notch increases, a larger shift of the first resonant frequency is observed. At a defect distance of

25mm, i.e. $x=0.1L$ and a depth of 1mm, the changes in resonance frequency are very small and below 1%. At $x=0.2L$, the frequency shift reaches about 2%. The most significant changes in the first resonant frequency are obtained at a notch in the middle of the composite beams. At a crack depth of 3mm, the frequency shift reaches 14%. Additionally, a beam with a depth $a=0.8h$ was investigated. The results show a relative change of about 64%. The results of the in-plane flexure tests are shown in Table II and Figure 7.

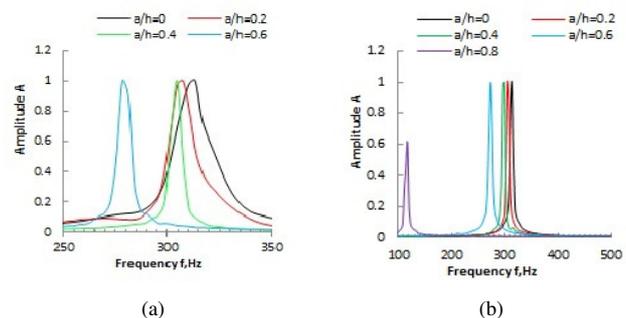
Fig. 6. First natural frequency of flexure vibration test for intact and damaged beams. (a) Notches located at $0.3L$ with different depths $0.2h$, $0.4h$, $0.6h$. (b) Notches located at $0.5L$ with different depths $0.2h$, $0.4h$, $0.6h$.

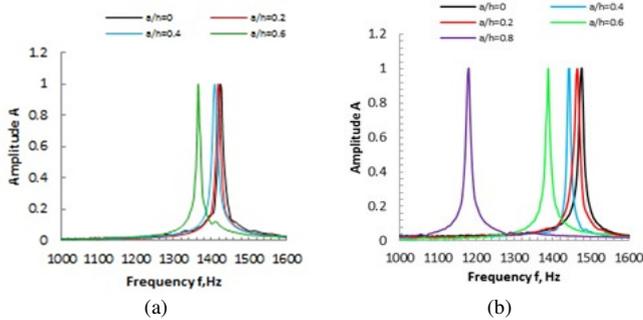
Fig. 7. First resonance frequency for in-plane flexure vibration. (a) Defect location $x/L=0.3$, defect depths $a/h = 0.2, 0.4,$ and 0.6 . (b) Defect location $x/L=0.5$, defect depths $a/h = 0.2, 0.4, 0.6,$ and 0.8 .

The relative shift of the first resonant frequency is not noticeable at defect location $x/L= 0.1$. As the x/L parameter increases, the frequency decreases and reaches 6% for the deepest crack. Figure 7 shows the frequency characteristics for slits at distances $x=0.3L$ and $0.5L$.

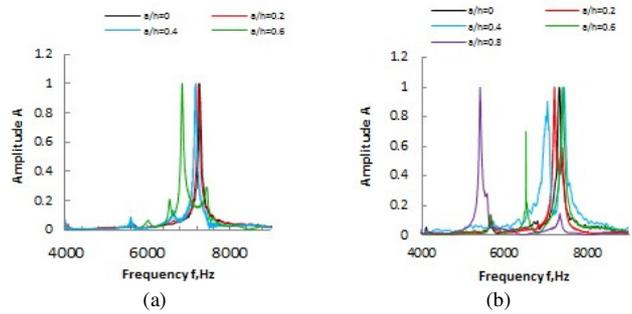
The results of the longitudinal vibration mode tests are shown in Table III and Figure 8. The frequency changes for dimensionless damage location equal to 0.5 and dimensionless depths of 0.6 and 0.8 are about 11% and 26%. If the impulse impact energy is evaluated, it can be concluded that at such small impulse energy the stresses and strains are very small. For this reason, a significant reduction in resonance frequency

Fig. 8. First resonance frequencies of longitudinal tests. (a) $x/L=0.3$ and defect depths $0.2h, 0.4h,$ and $0.6h$. (b) $x/L=0.5$ and defect depths $0.2h, 0.4h, 0.6h,$ and $0.8h$.

is recorded when the material thickness at the defect site is at least 5 times smaller than the specimen thickness.

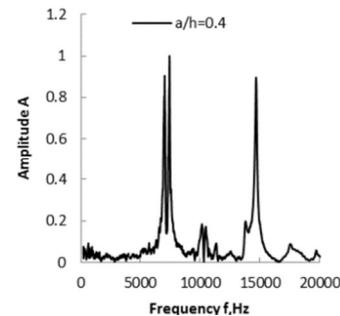
Another phenomenon that is evident in the frequency response function of damaged beams is the appearance of double peaks as shown in Figure 9. Double peaks indicate two resonances that are close. This phenomenon is called "breathing" [28]. It shows up as an irregular "broken peak" on the frequency response. Breathing causes variations in local stiffness which is time, frequency, and amplitude-dependent.

Fig. 9. The "broken peak" phenomenon in frequency response function.

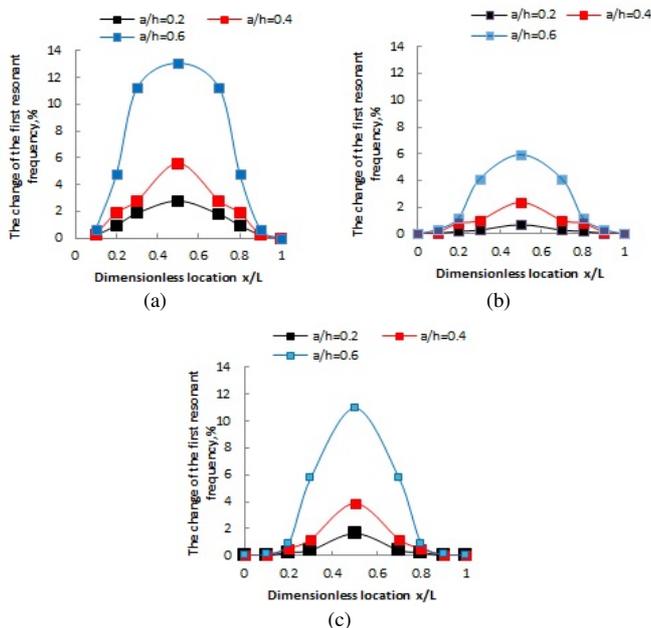
Figure 10 presents the effect of defect position and depth on the resonance frequency for flexure and longitudinal vibrations. Maximum values of the Δf are obtained at the deepest crack ($a=0.6h$), located at a distance of $x=0.5L$. The frequency shifts are 13%, 6%, and 11% for the out-of-plane, in-plane and longitudinal mode vibrations, respectively.

Fig. 10. Effect of defect location on frequency shift: (a) out-of-plane flexure mode, (b) in-plane flexure mode, (c) longitudinal mode.
