DOI: 10.21625/essd.v4i1.490

Energy Rehabilitation of Social Housing in Vulnerable Areas**Case study: a 1950s Building in a Medium-sized Mediterranean City****Ruá María José¹, Huedo Patricia¹, Cabeza Manuel², Saez Beatriz², Civera Vicente¹**¹*Mechanical Engineering and Construction Department*²*Industrial Systems Engineering and Design Department. Jaume I University***Abstract**

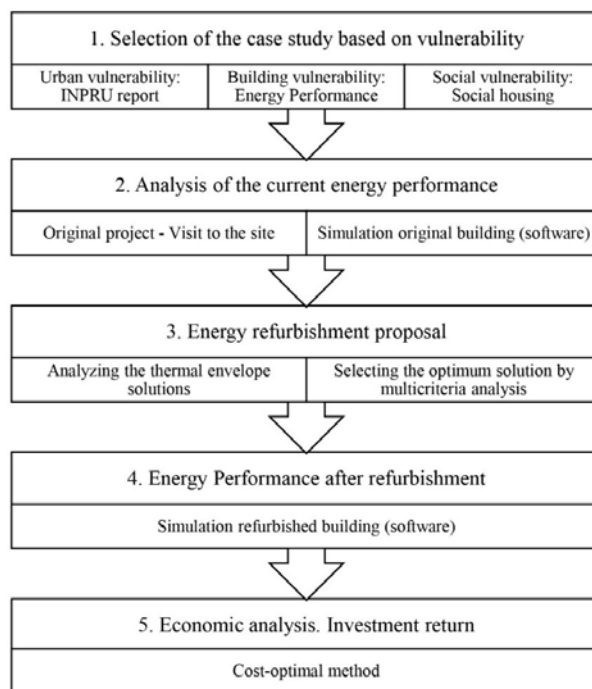
Figure 1. Methodology

Some stages were followed (see Figure 1) to undertake this work. First, the case study was selected according to three main pillars. On the one hand, the urban area was selected based on a previous work in which vulnerable urban areas of the city were defined. On the other hand, the building’s poor energy performance was the main observed feature. Finally, the building’s social housing condition guaranteed vulnerable dwellers, e.g., low-income citizens.

Once the building was selected, a diagnosis of its current state was made by analysing the scarce available project information and visiting the site to collect complementary and necessary information. This permitted the building to be simulated in officially recognised software to determine its energy performance. The third stage consisted in analysing the refurbishment solutions and selecting the optimal solution according to a multicriteria analysis after bearing in mind the actual conditions the building was in by looking for a real applicable one.

The fourth stage consisted in determining the building's energy performance after refurbishment. Finally, economic feasibility was estimated by the cost-optimal method to acquire an order of magnitude of the investment and other costs.

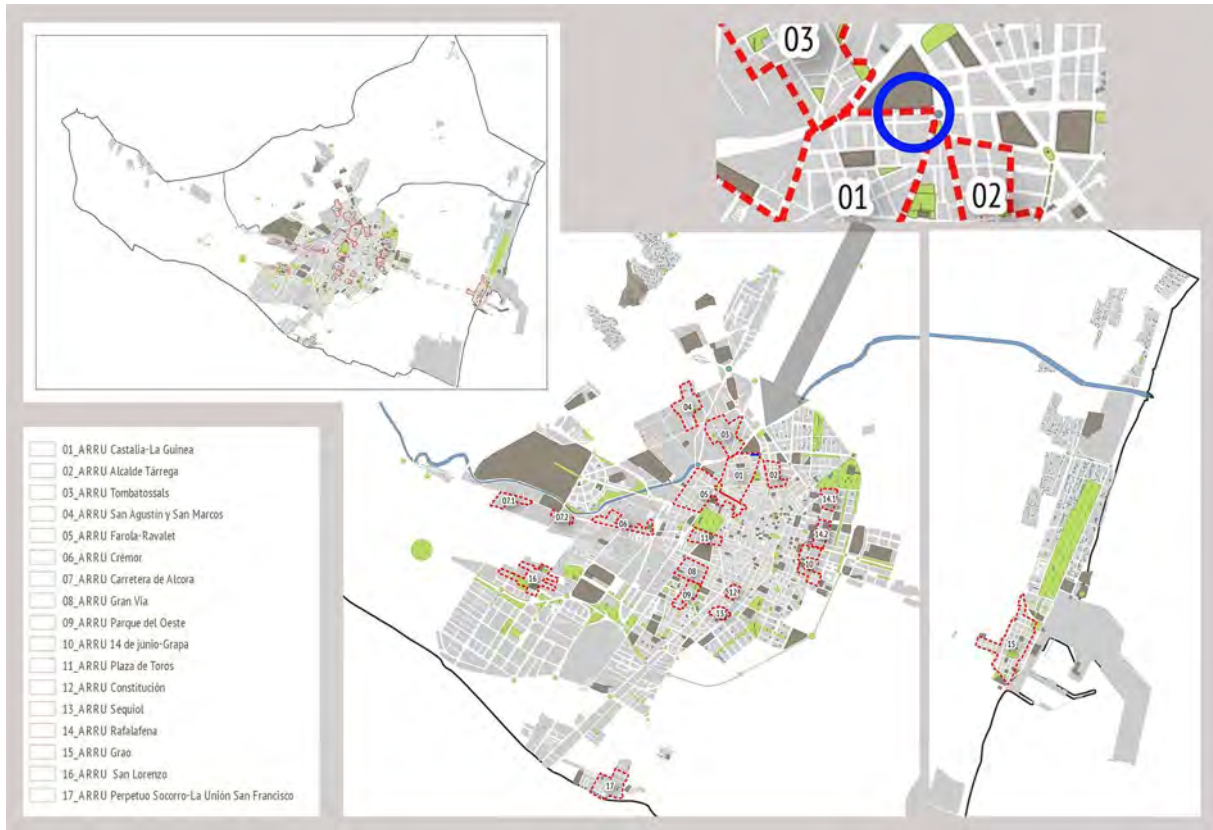
Figure 2. Situation

The development of the new Land Use Plan of the city of Castellón de la Plana (Spain) needs to define ARRUs. This definition was created by using 29 *ad hoc* selected indicators of vulnerability. They were grouped into four categories: urban (4), building (4), socio-demographic (16) and socio-economic indicators. The ARRUs were those areas where all the categories concurred, so they presented multidimensional vulnerability. As a result, 17 ARRUs were defined in the city (García Bernal et al., 2017; Ruá et al., 2017). The building used as a case study in this work is included in one of the ARRUs. The defined ARRUs are indicated in Figure 2. The selected block of buildings is included in ARRU 01. The location of the block is indicated in the top-right corner of Figure 2.

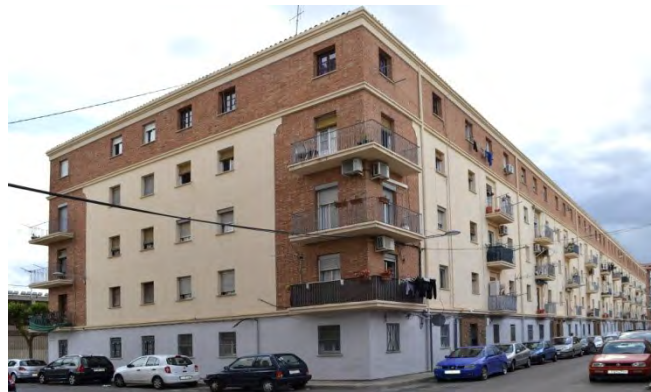
Figure 3. General view

The block of buildings was built in 1959 as social housing by Ministry of Housing subsidy. The group is formed by 12 buildings, the north façade, with odd numbers 1 to 11, to Huesca Street, and opposite the Castalia football stadium. The south façade is in Martínez Tena Street, numbers 2 to 12. Figure 3 shows a general view of the block of buildings. The block forms an internal courtyard and each building is formed by one ground floor and four upper floors, with two dwellings per floor, which means 10 houses per block and 120 houses in all, which account for 2339 m².

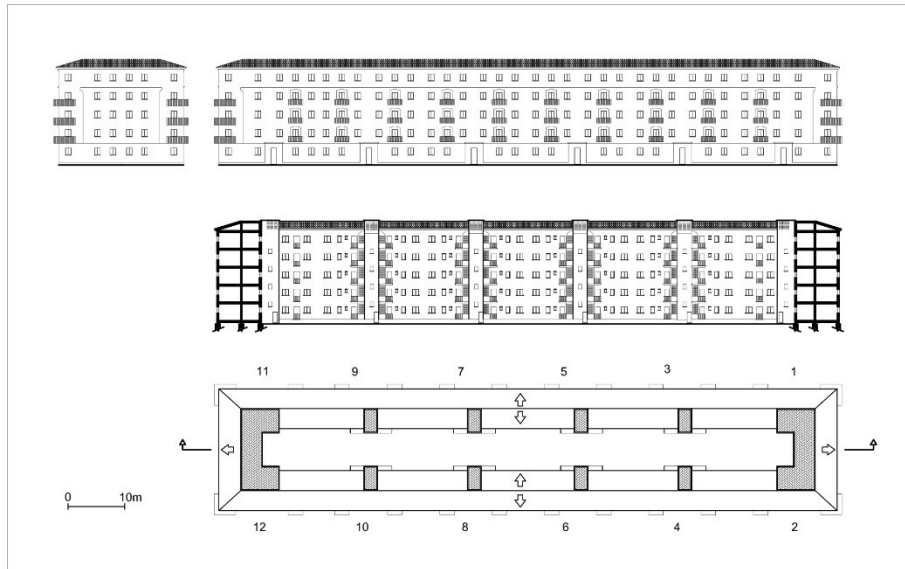
Figure 4. Front side view, side elevation, section and roof plans

Figure 4 shows the front side view and the side elevation plan, section and roof plan. Figure 5 represents a 3D image of the block using the Revit software, drawn after the visits made to the site.

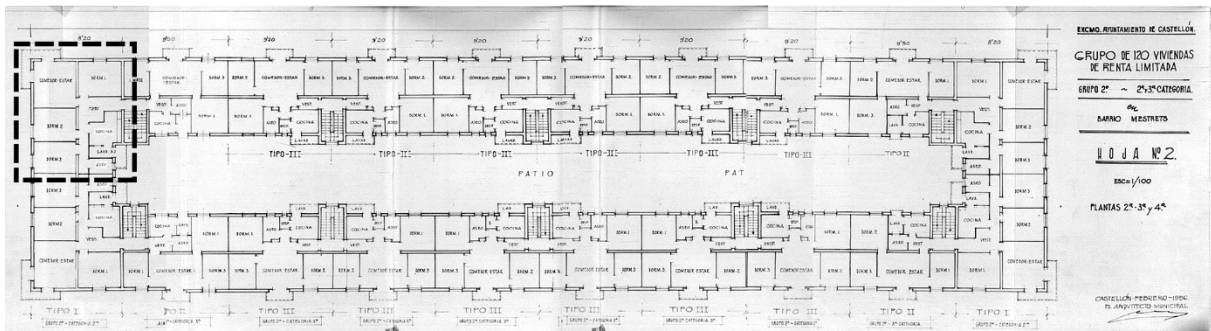
Figure 6. Second Floor (Original plans)

There are four buildings in the corners of the block, while the rest are terraced buildings which present better energy performance as they are less exposed to the outer environment. The building located in the north-west corner (357° north) is the worst in energy performance terms. In order to simplify simulation, only this building was simulated. There are three types of housing, as seen in the original plans presented in Figure 6, where the selected building is indicated. Figure 7 shows the floor plan, with dwellings types I and II, included in the building selected in the block. Dwelling type III is included in the terraced buildings in the block.

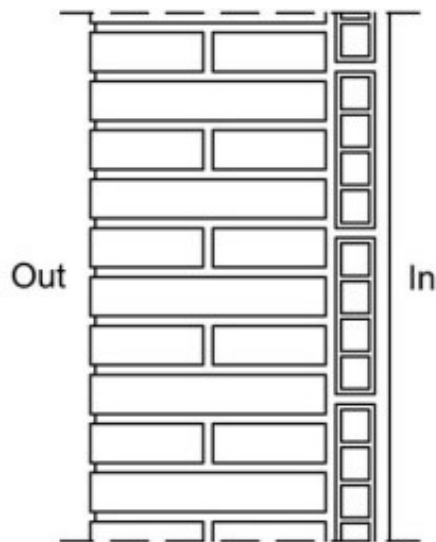
Figure 8.

Thermal envelope	Constructive solution	Transmittance U (W/m ² K)	Figure
Façade 1	Bearing wall formed by double leaf brick: exterior masonry wall of ceramic solid brick of 1 foot-thick with cement mortar joints + inner skin of hollow ceramic brick, 4-cm thick, with cement mortar joints + plastering. Exposed area: N 93.41 m ² ; W 78.93 m ²	1.44	Figure 8

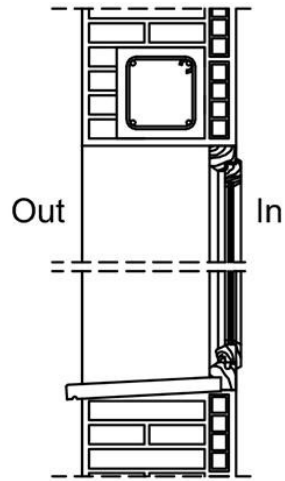
Figure 9.

<p>Façade 2</p>	<p>Bearing wall formed by double leaf brick: continuous outer coating with cement mortar + exterior masonry wall of ceramic solid brick of 1 foot-thick with cement mortar joints + inner skin of hollow ceramic brick 4 cm-thick with cement mortar joints + plastering. Exposed area: N 190.64 m²; W 100.63 m²; E 57.84 m²; S 169.51 m²</p>	<p>1.29</p>	<p>Figure 8</p>
<p>Windows</p>	<p>Wood carpentry with single glazing.</p>	<p>Carpentry: 2.20 Glazing: 5.50</p>	<p>Figure 9</p>
<p>Roof 1</p>	<p>Flat roof ventilated, trafficable: Finishing ceramic tiles + mortar layer 5 cm + bituminous sheet + ventilated air chamber + reinforced concrete one-way slab 30 cm, ceramic hollow plot + plastering. Exposed area: 38.83 m².</p>	<p>1.37</p>	<p>Figure 10</p>
<p>Roof 2</p>	<p>Gable sloping roof ventilated 16°: finishing ceramic gables + mortar layer + ceramic tiles for roof slope + ventilated air chamber + reinforced concrete one-way slab 30 cm, ceramic hollow plot + plastering. Exposed area: 116.03 m².</p>	<p>1.05</p>	<p>Figure 11</p>

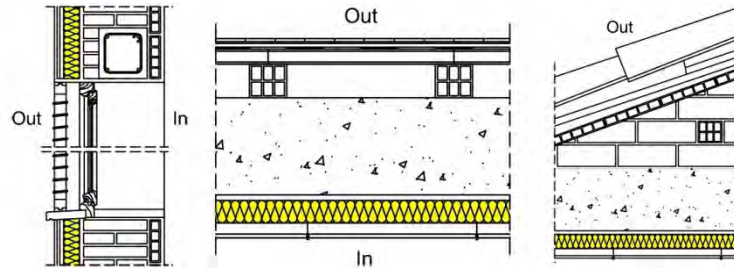
Figure 13. Façade, sloping roof and flat roof refurbishment solutions

Table 3 shows some constructive solutions (Huedo, Mulet & López-Mesa, 2016), along with their advantages, disadvantages and features by bearing in mind the technical, environmental, economic and heritage perspectives. The selected solutions are shaded in grey in Table 3 and represented in Figure 13. For façades, inner insulation (FI) was ruled out because of the dimensions of rooms. It would mean reducing the areas of rooms as they could not fulfil the minimum required dimensions according to new standards. Therefore, the outer solution with the External Insulation System was adopted in this case because it was more convenient than the ventilated façade,

For roofs, the inner solution proved more convenience when looking at advantages and disadvantages. The same solution involving mineral wool and finishing plaster board could be applied to roof 1 (SRI) and roof 2 (FRI).

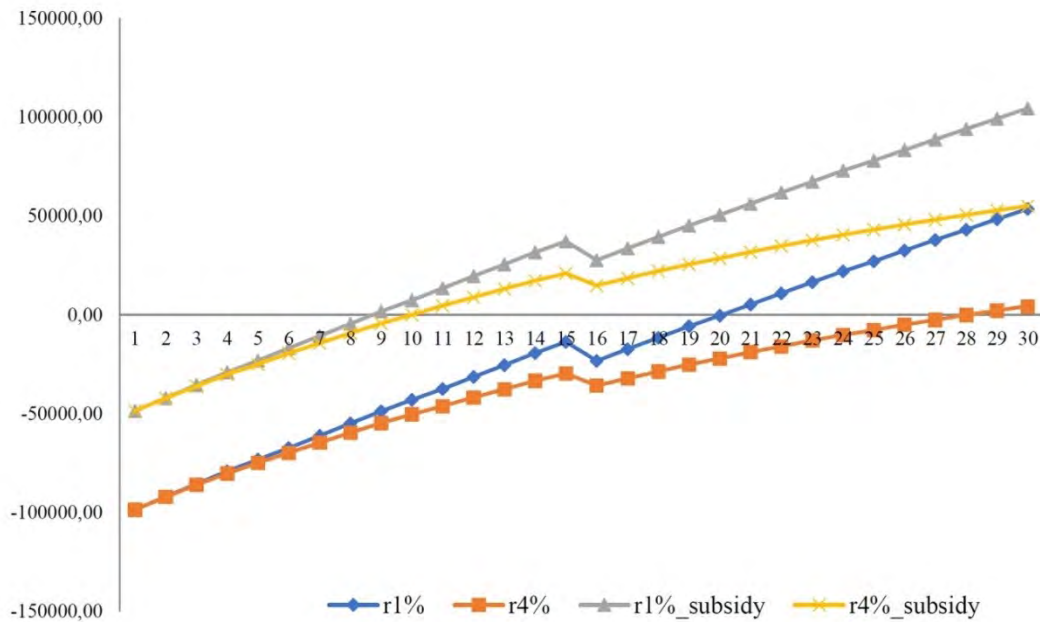
Figure 14. Façade, sloping roof and flat roof refurbishment solutions

The graphic represented in Figure 8 shows the accumulated NPV for two discount rates, 1% and 4%. NPV is €53,184.12 for 1% and is €4,736.1 for 4%. With the starting hypothesis of Table 5, we can see that the investment starts to be positive from year 20 and 28 for the 1% and the 4% discount rate, respectively. This is not a surprising result if we consider the private costs and only the carbon price a social cost.

Some subsidies can be considered in the calculations, if we bear in mind that the building is included in an ARRÚ, as mentioned in Section 3.1. This would result in a more optimistic scenario with a shorter payback, as calculated in previous studies (Alguacil et al., 2017). For example, estimating a hypothetical subsidy of €5,000.00/dwelling, the investment would be returned in less time, as seen in Figure 14.
