# GEOTECHNICAL DESIGN OF BREAKWATERS IN OSTEND ON VERY SOFT SOIL

Two new breakwaters are being constructed to protect the renewed harbour entrance in Ostend, Belgium. In this paper, both the hydraulic design and geotechnical design are discussed. For the hydraulic design, model tests have been carried out in a 2-D wave flume to optimise the cross section. Stability of the final breakwater, with special attention to the crest element and the armour unit HARO, and stability during the construction phases were tested. The geotechnical design, especially of the north-western breakwater, was an engineering challenge since it is located above a thick layer of very soft soil. A combination of building in stages (consolidation time) and providing a strong reinforcement (geotextile) solved this issue.

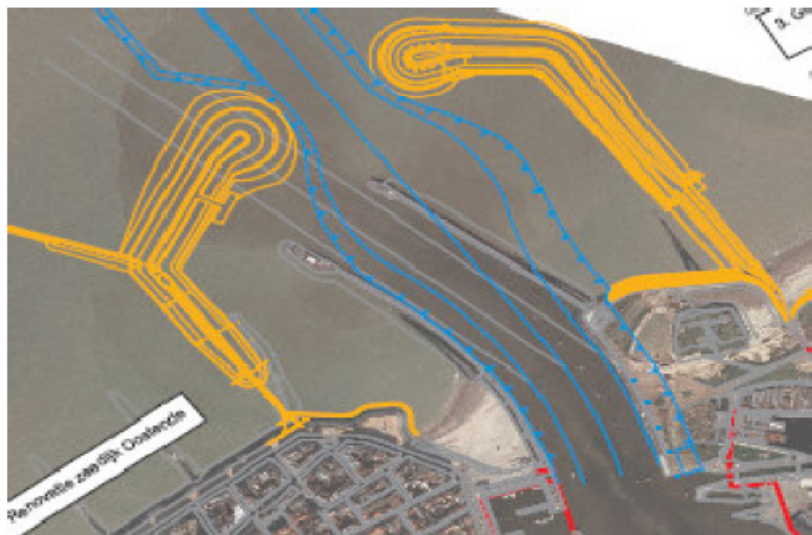
**Figure 1. Old harbour entrance (grey lines) is replaced by the new entrance (blue lines) and protected by 2 new breakwaters (yellow lines).**

Despite being a relatively small harbour, Ostend, a city situated in the middle of the Belgian coastline, plays an important role in the southern North Sea. The harbour of Ostend is a versatile short sea port, but it mainly focuses on passenger and car-ferry transport. Due to the economical progression, port infrastructures need to be improved and enlarged. Until 2008, the harbour entrance was protected by 2 jetties that were oriented to the north-west. Since this was not perpendicular to the harbour mouth, ships were forced to make an S-curve to enter the harbour. The harbour of Ostend therefore was limited to ships of 120m. To make the port accessible to ships up to 200m, the harbour entrance is reoriented to the north and two new breakwaters are being constructed on both sides of the access channel (Figure 1).

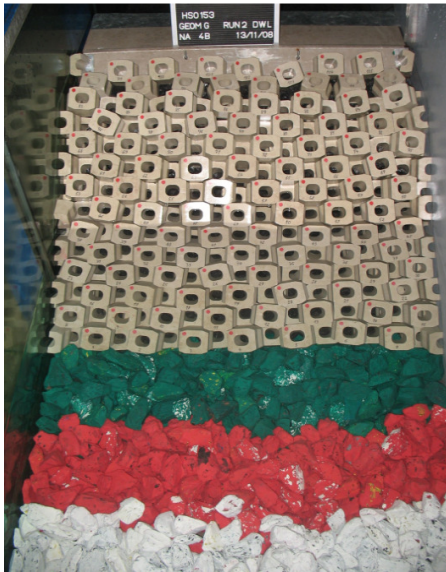
Figure 6. Double layer HAROs as armour layer on the seaside of the breakwaters

Going from the coast (south) to the sea (north), the armour layer of the seaside of both breakwaters consists of 3-6 ton rocks and a transition zone with 1 layer of HAROs. Finally, the most northern part of the breakwaters is armoured with 2 layers of HAROs (Figure 6). Model tests show a very high stability of the HAROs under wave attack of 5m and higher, with only 1% of the blocks moving more than half of their width, and no blocks moving over a distance equal to their width (Figure 7).

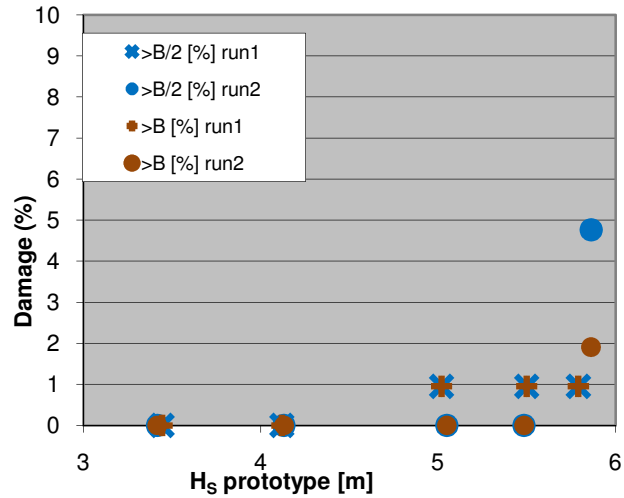
Figure 7. Damage graph of the double layer HAROs under increasing wave impact.

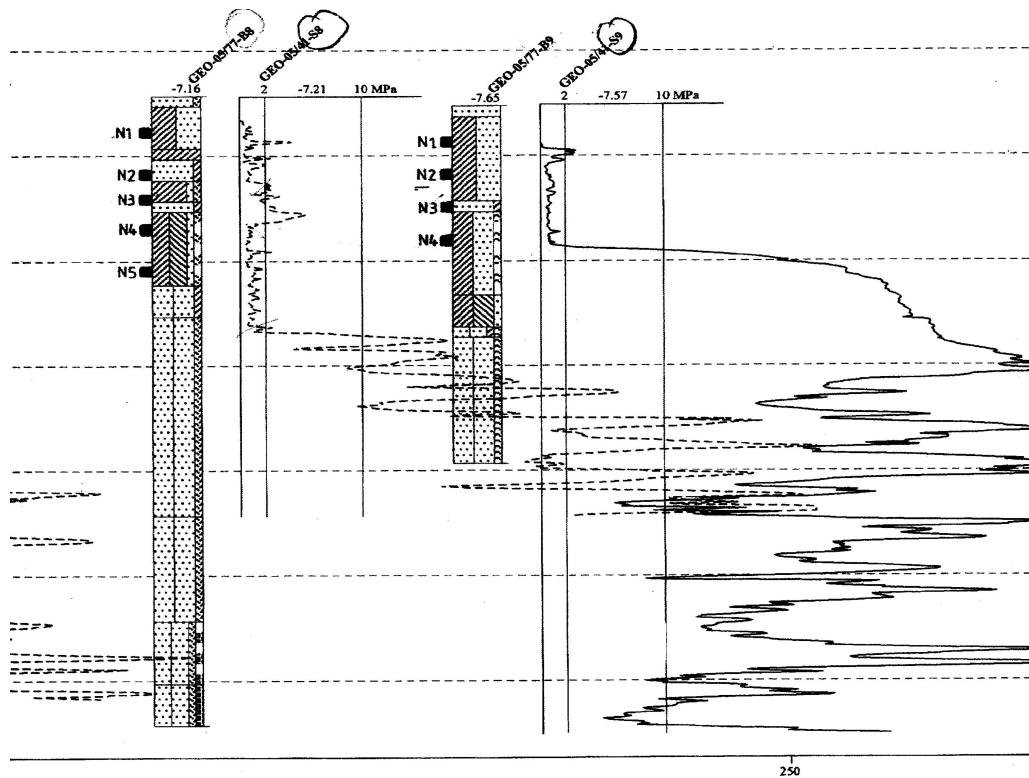
Figure 9. Two CPTs close to each other, at the location of the NW breakwater

At the location of the south-western breakwater, soil layers were found that are similar to those at the eastern breakwater. However, at the location of the northern part of the western breakwater, very soft soil layers were discovered over a length of 350m. The thickness of these layers varies drastically from one CPT to another (Figure 9).

The weakest subsoil is found at the locations of CPT S8 and CPT S9 (Figure 9). Calculations have been performed using these CPTs.

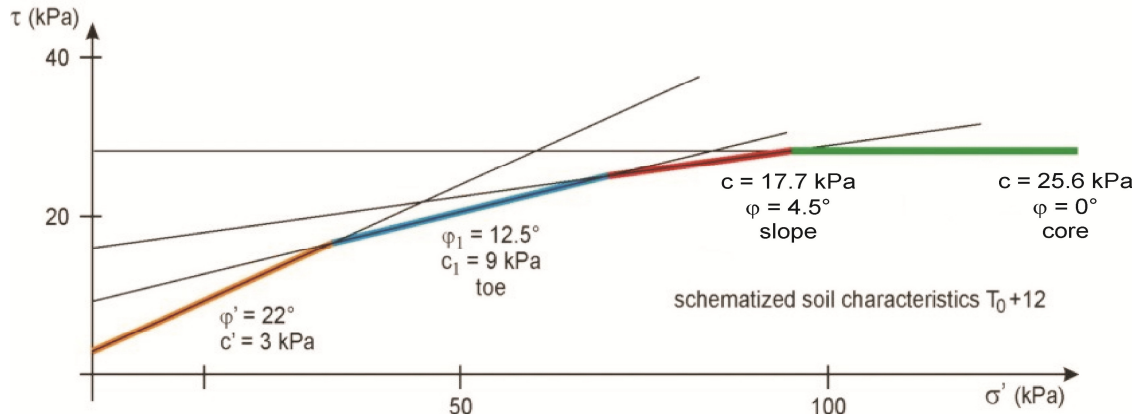
Figure 15. Variation of the soil characteristics in the cross section at a given time ( $T_0 + 12$ )

Figure 14 schematically shows the construction phases in terms of time. The construction time needed to pass from one construction phase to another at a certain cross section is schematised as immediate loading: a vertical line in Figure 14. Figure 15 shows the calculated soil characteristics at  $T_0 + 12$  at different locations of the cross section: seaward of the toe, underneath the toe and the slope, and underneath the core.

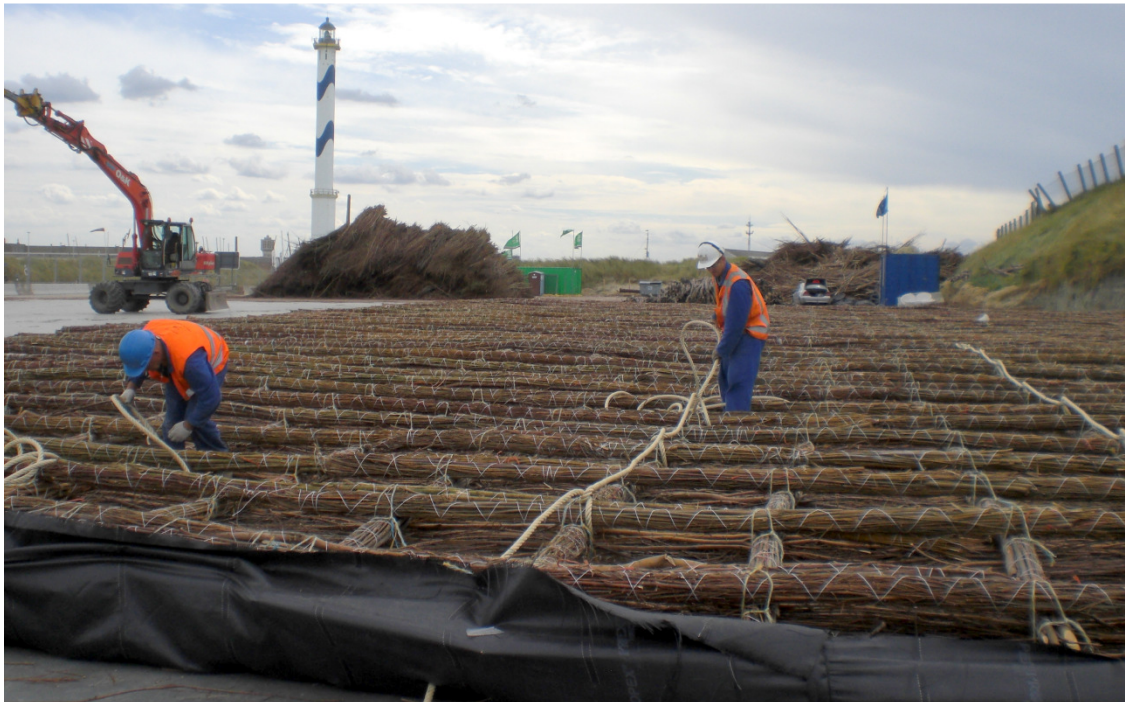
**Figure 18. Willow mattress ready to be towed into the sea**

It is much thicker and stiffer than a common geotextile, but the on-site processing occurs in a similar manner. The 5m wide super geotextile is delivered by the manufacturer and processed into mats of 20m wide and 40 to 50m long. Next, willow branches are attached in a crossed pattern to the super geotextile. Once ready, this mattress is dragged into the water at high water tide, and towed into position at the moment of minimal tidal currents. Rock gradations 10-60kg and 60-300kg are used as ballast (800kg/m<sup>2</sup>).
