# MONITORING A NATURAL COBBLE BERM TO INFORM NATURE-BASED SOLUTIONS FOR HIGH-ENERGY COASTS

Michelle Gostic, PE, Washington State Department of Ecology, [mgos461@ecy.wa.gov](mailto:mgos461@ecy.wa.gov)  
George M. Kaminsky, PhD, PE, Washington State Department of Ecology, [gkam461@ecy.wa.gov](mailto:gkam461@ecy.wa.gov)  
Heather Weiner, Washington State Department of Ecology, [hbar461@ecy.wa.gov](mailto:hbar461@ecy.wa.gov)  
Amanda Hacking, Washington State Department of Ecology, [amha461@ecy.wa.gov](mailto:amha461@ecy.wa.gov)  
Gabby Alampay, GIT, Washington State Department of Ecology, [gala461@ecy.wa.gov](mailto:gala461@ecy.wa.gov)  
Heather Maran, Washington State Department of Ecology, [heam461@ecy.wa.gov](mailto:heam461@ecy.wa.gov)

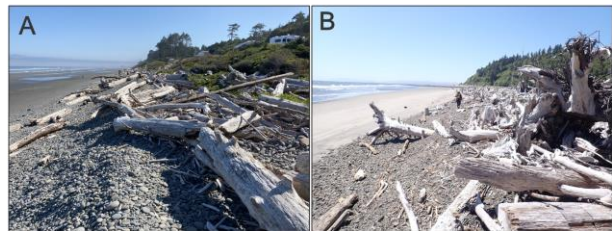
Figure 1 - Plat A: naturally occurring composite beach at Kalaloch, Washington with a cobble berm backing a sandy foreshore; Plat B: constructed dynamic revetment at North Cove, Washington.

To advance our understanding of nature-based dynamic revetments, this work evaluates five years of monitoring data of a natural composite beach near Kalaloch in Northwest Washington State. The beach consists of a natural cobble berm, which backs a sandy foreshore and fronts a coastal bluff. The site serves as a natural analog to installed dynamic revetments elsewhere along Washington's Pacific Ocean shoreline. By studying the geometry, morphology, and composition of this naturally occurring feature, we can better define the types of shorelines suited for successful dynamic revetment
