## An engineering geological appraisal of the Chamshir dam foundation using DMR classification and kinematic analysis, southwest of Iran

This paper describes the results of engineering geological investigations and rock mechanics studies carried out at the proposed Chamshir dam site. It is proposed that a 155 m high solid concrete gravity-arc dam be built across the Zuhreh River to the southeast of the city of Gachsaran in south-western Iran. The dam and its associated structures are mainly located on the Mishan formation. Analysis consisted of rock mass classification and a kinematic analysis of the dam foundation's rock masses. The studies were carried out in the field and the laboratory. The field studies included geological mapping, intensive discontinuity surveying, core drilling and sampling for laboratory testing. Rock mass classifications were made in line with RMR and DMR classification for the dam foundation. Dam foundation analysis regarding stability using DMR classification and kinematic analysis indicated that the left abutment's rock foundation (area 2) was unstable for planar, wedge and toppling failure modes.

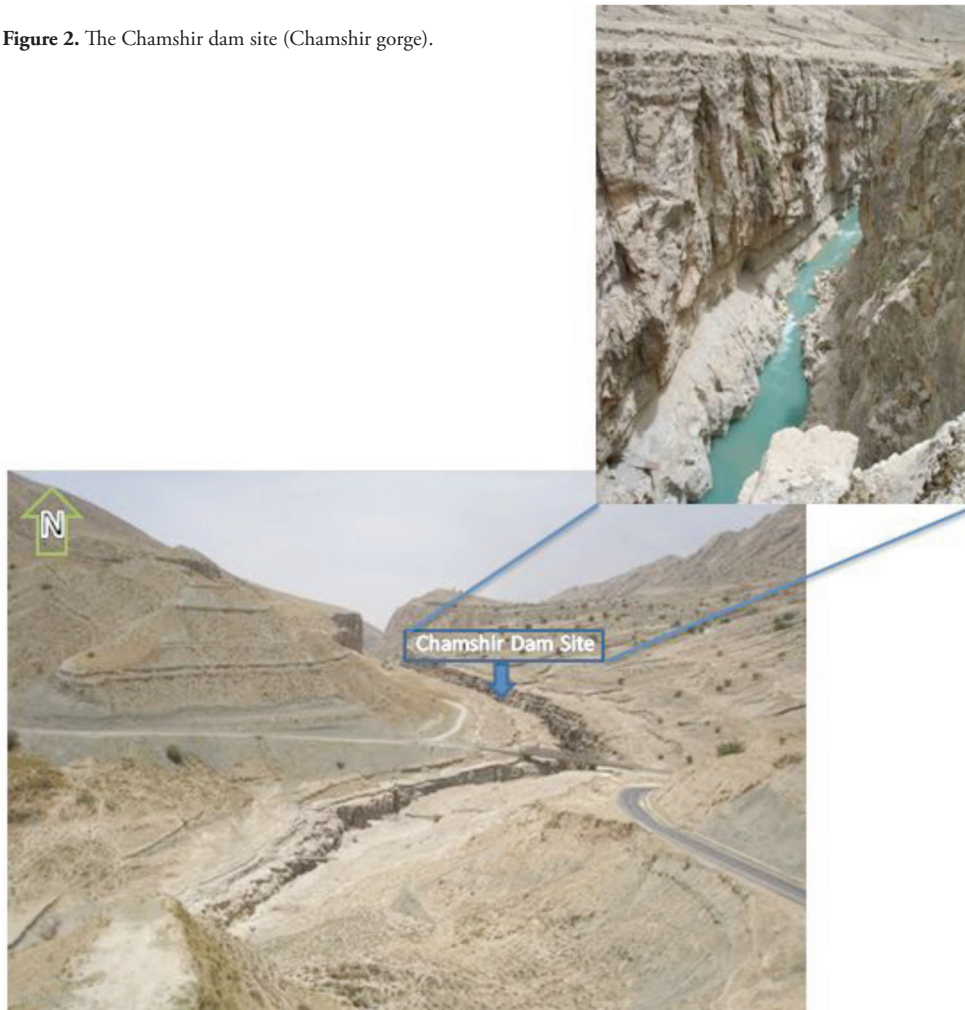
**Figure 2.** The Chamshir dam site (Chamshir gorge).

The Chamshir dam site on the Zuhreh river is located in south-western Iran, about 20 km southeast of the city of Gachsaran (50° 52' 36" E and 30° 10' 59" N, Figure 1). The dam is now being studied and has been designed as a 155 meter high concrete gravity-arc dam; its useful reservoir volume is 1.8 milliard cubic meters (Figures 1 and 2). Exceptional topographical, hydrological and geological circumstances regarding the river
