# INTEGRATION OF HYBRID OUTDOOR AND INDOOR SURVEYING. A CASE STUDY IN SPANISH RENAISSANCE STYLE TOWERS.

**Keywords:** Architectural Surveying, range-based methods, Renaissance towers, conservation interventions.

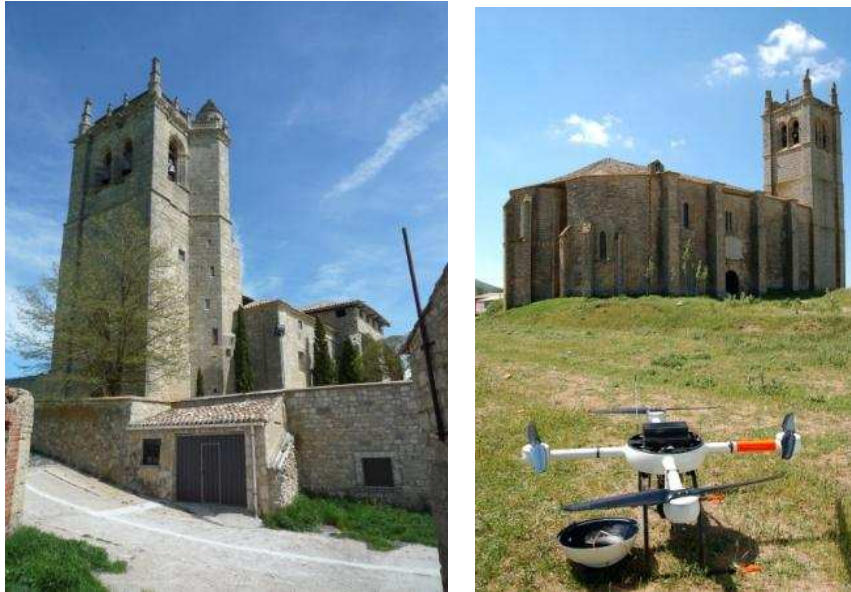
Figure 1: 1) Tower of Santiago's Church, Castrillo de Murcia, Spain. 2) md4-100 capturing aerial images.

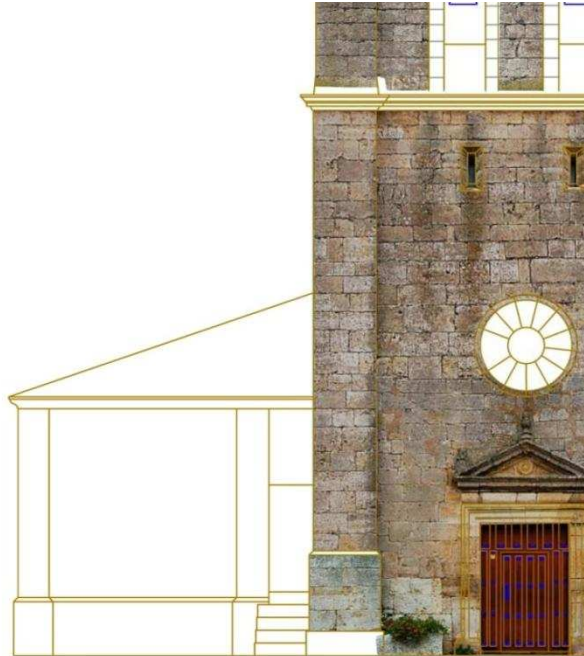
Figure 8: Photo grinding walls in the tower of the Santa Marina's church in Villadiego, Spain.

The analysis of local details involving ashlar and rough stones to solve the tower parameters is dealt with three techniques. 1) a direct reading of the coloured point clouds which have been processed for generating vertical or frontal views in the most appropriate resolution. 2) a rectification of views with AsRix, which provides the assembling way of fabrics, as much as their texture and colour constrained due to the lack of coplanarity. 3) a drawing reactivation (Homograft) to translate the formal aspects involving the walls fabrics.
